**SUBJECT: REMOVAL ACTION SAMPLING REPORT
PORT REFINERY SITE (55 HILLANDALE ROAD)
RYE BROOK, WESTCHESTER COUNTY, NEW YORK**

REMOVAL ACTION SAMPLING REPORT

PORT REFINERY SITE (55 HILLANDALE ROAD)

Rye Brook, Westchester County, New York

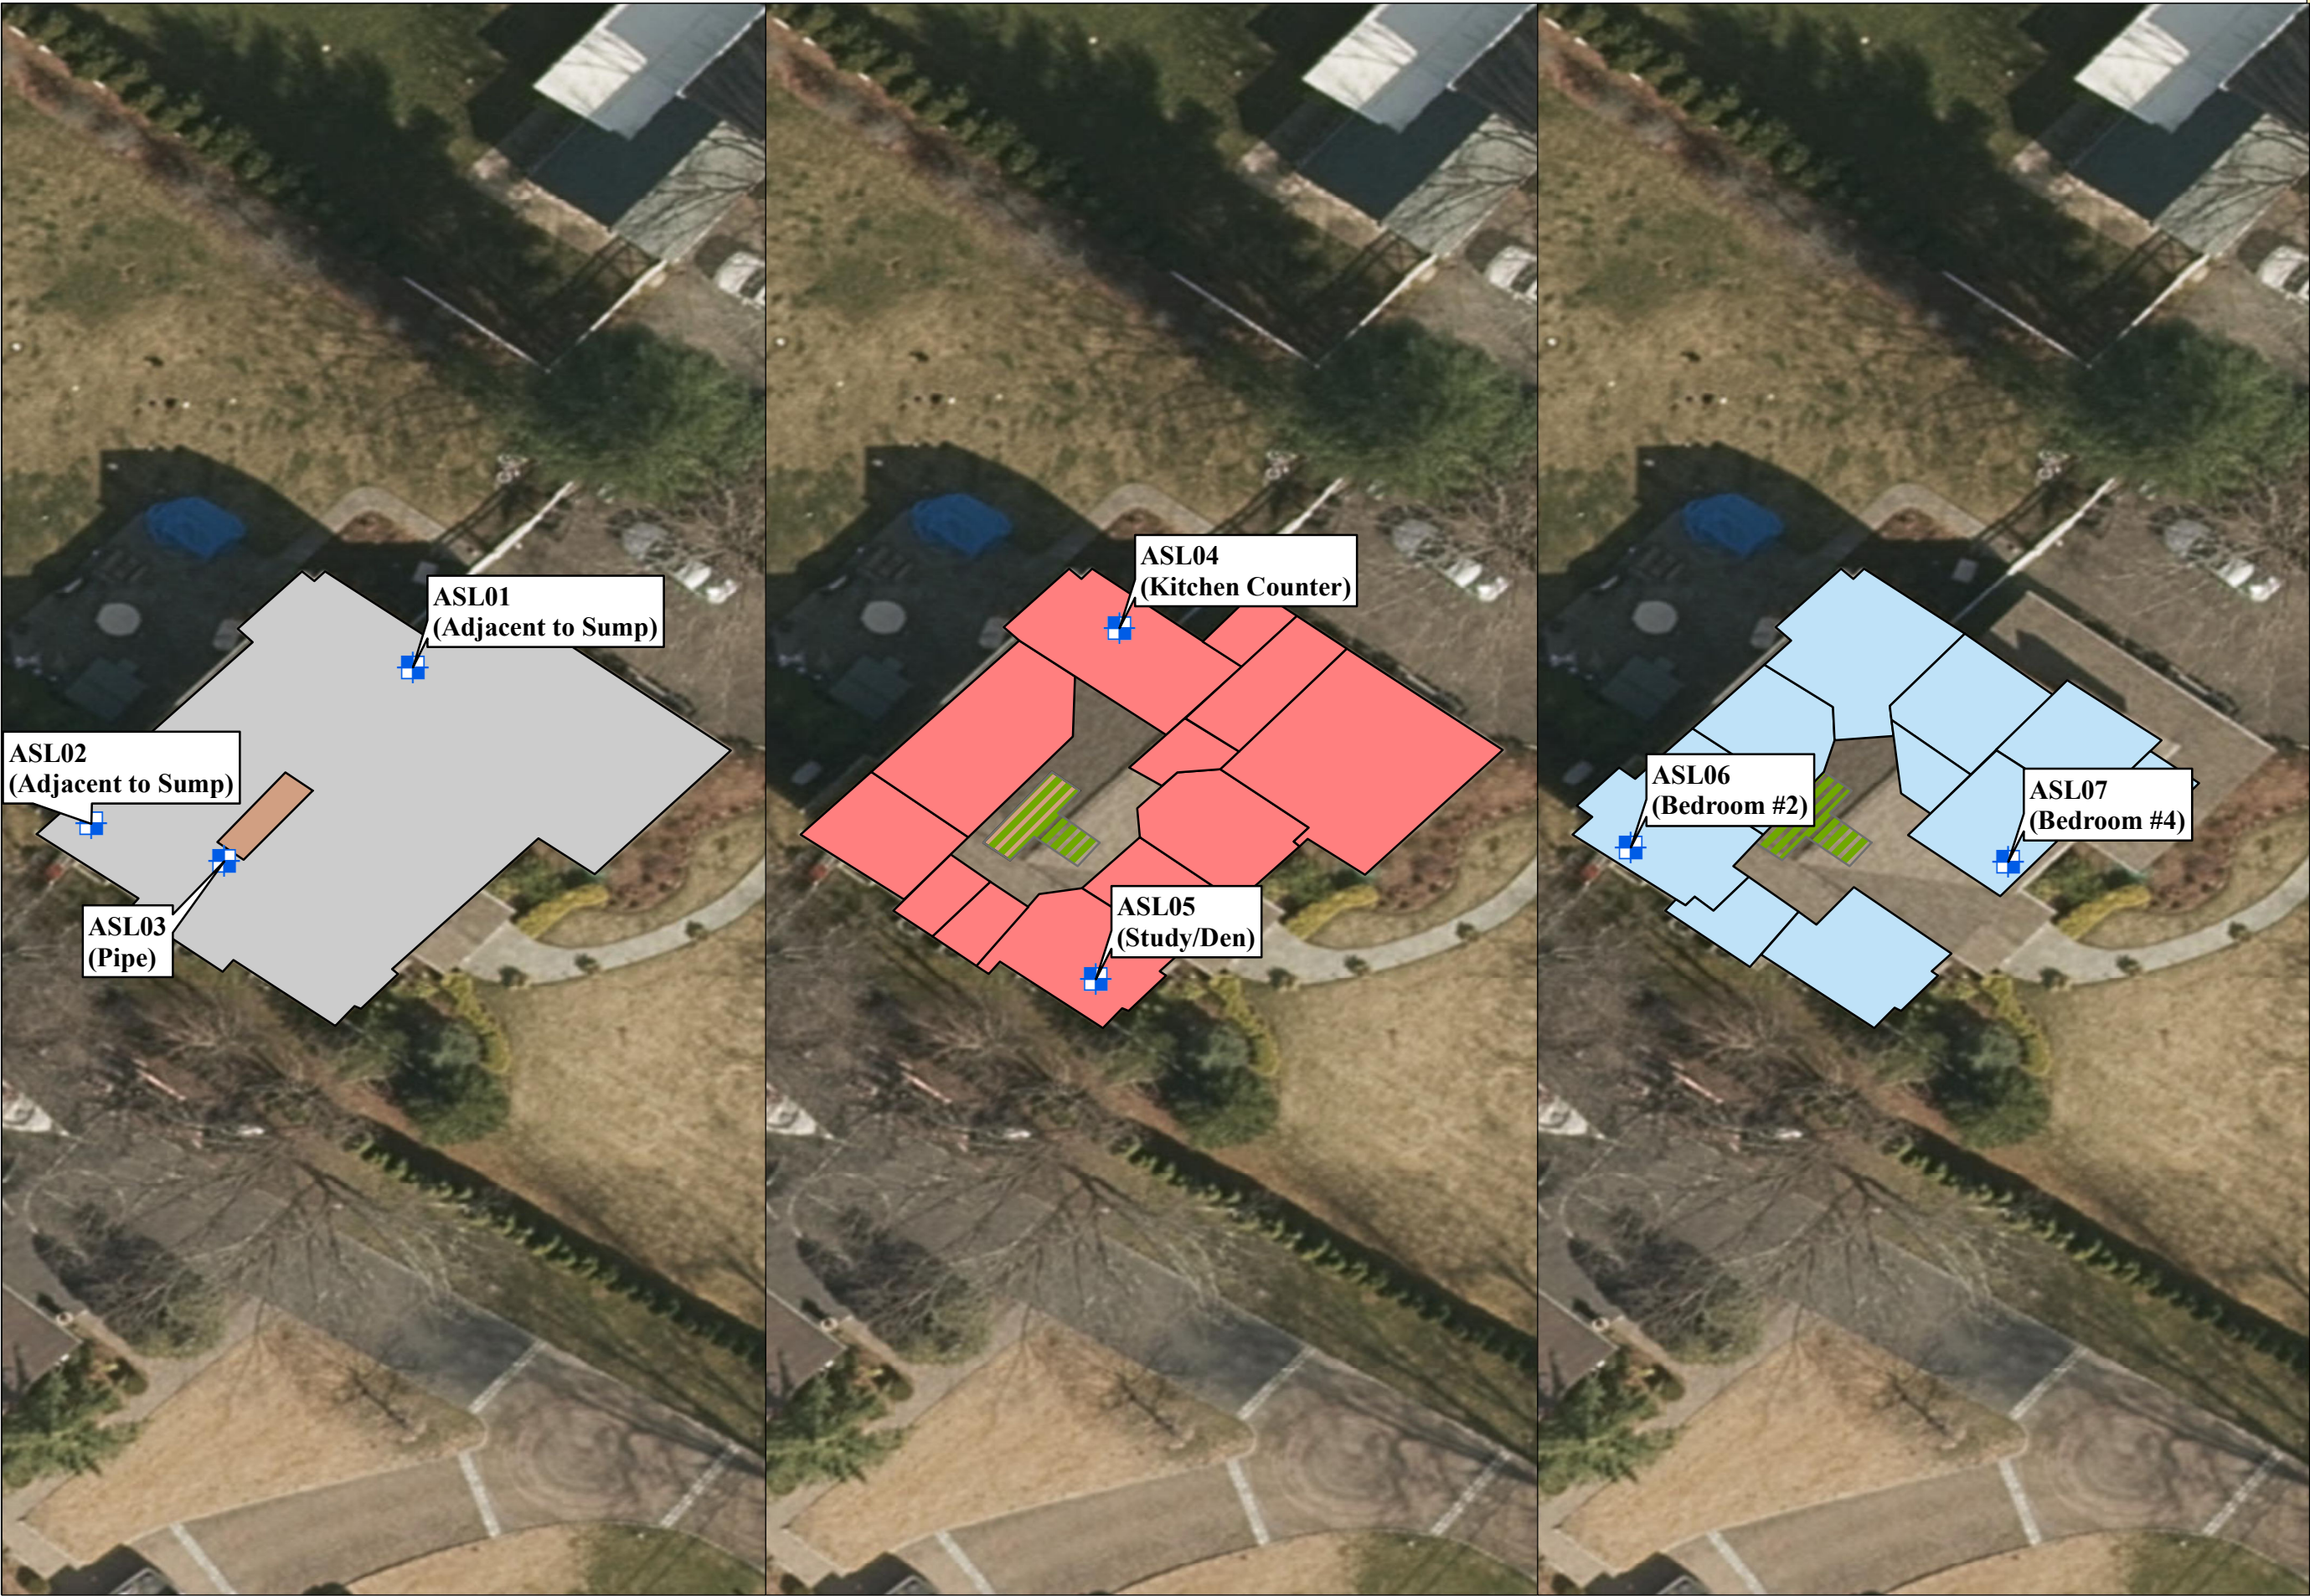
Figure 2: Sample Location Map

- LEGEND**
- Sample Locations
 - Basement
 - First Floor
 - Second Floor
 - Stairs (Basement)
 - Stairs

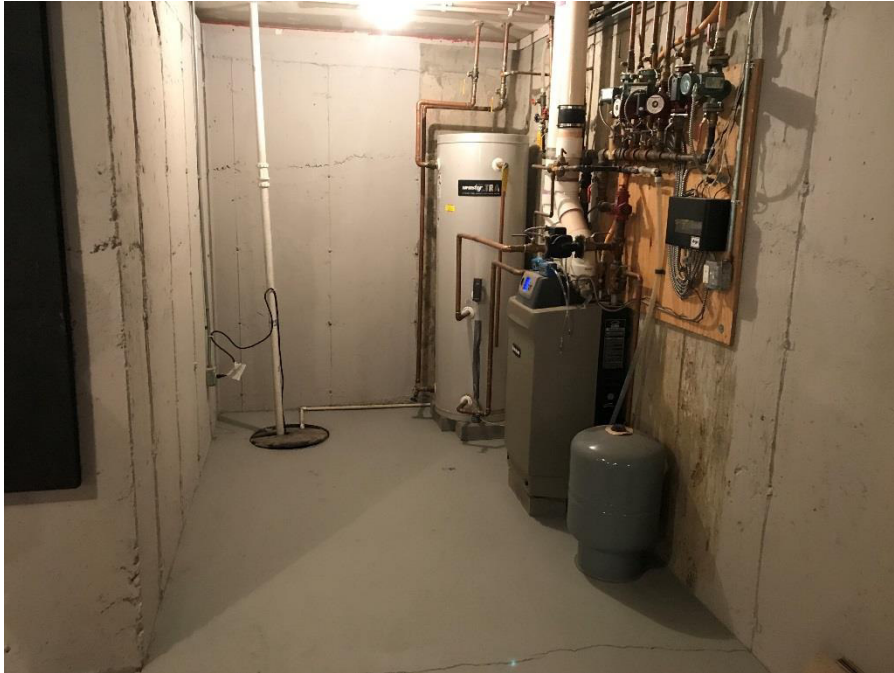
Photograph 1: View of air sampling location ASL01 adjacent to a sump in the basement. Air samples 190205-ASL01-AS01-01 and 190205-ASL01-AS08-01 were collected at this location. Air sampling was performed as part of a U.S. Environmental Protection Agency (EPA) Removal Action by Weston Solutions, Inc., Removal Support Team 3 (RST 3) and consisted of sorbent tubes attached to GilAir pumps with flow rates set between 0.15 and 0.25 liters per minute (L/min). All air sampling was conducted at 55 Hillandale Road, Rye Brook, New York.

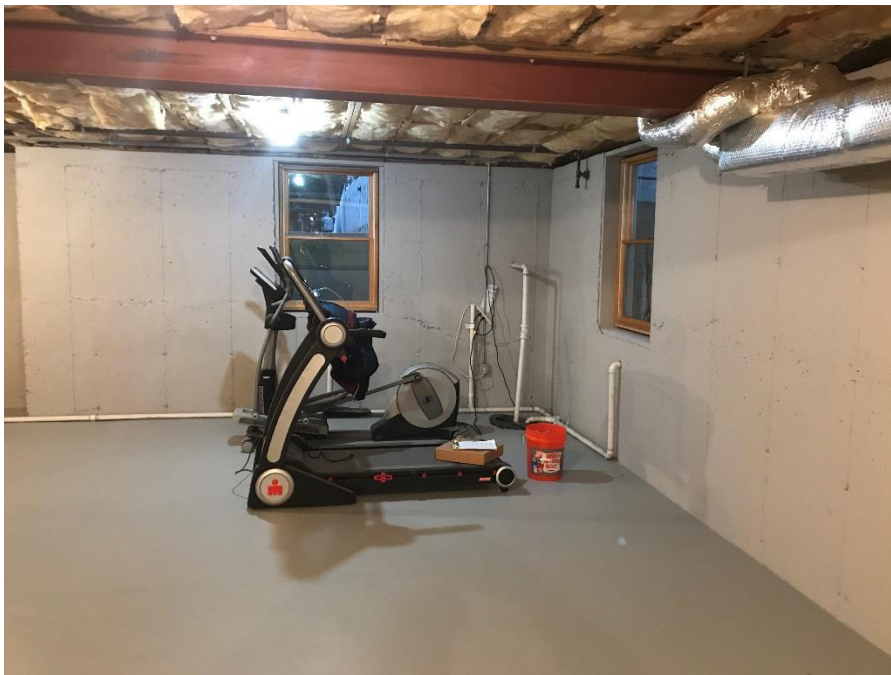
Photograph 2: View of ASL02 adjacent to a sump in the basement. 190205-ASL02-AS02-01 was collected at this location.

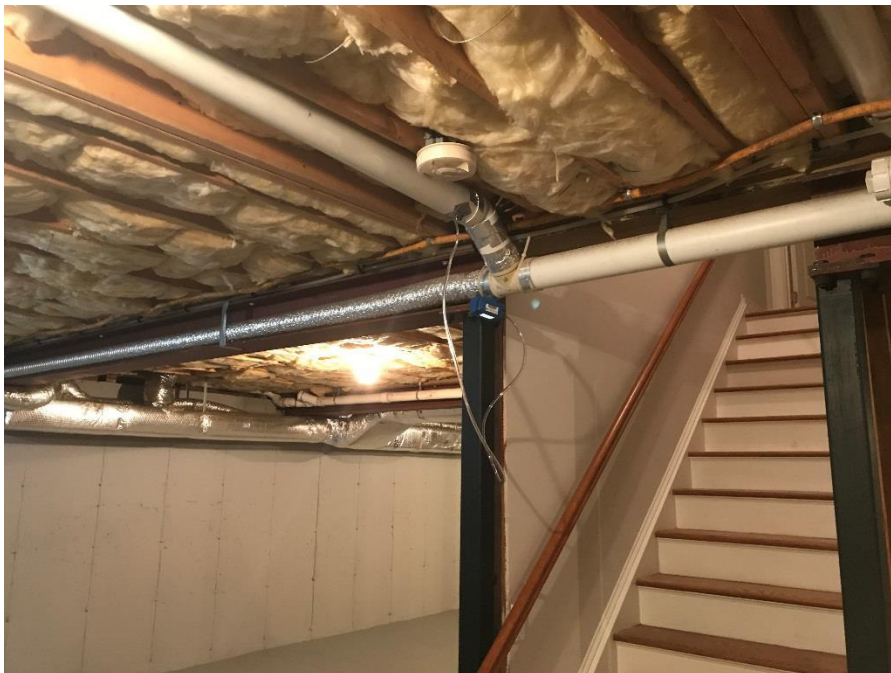
Photograph 3: View of ASL03 in a pipe in the basement. 190205-ASL03-AS03-01 was collected at this location. At this location, a small hole was drilled in the pipe and the sorbent tube was placed in the hole to collect the sample.

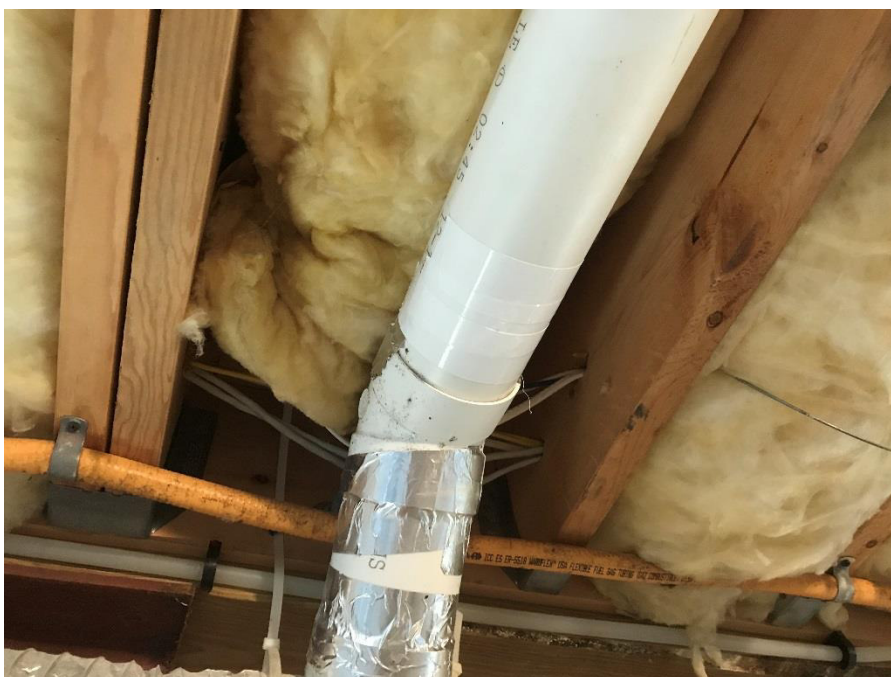
Photograph 4: View of ASL03 after air sampling was completed. The hole was sealed shut with caulk and white duct tape.

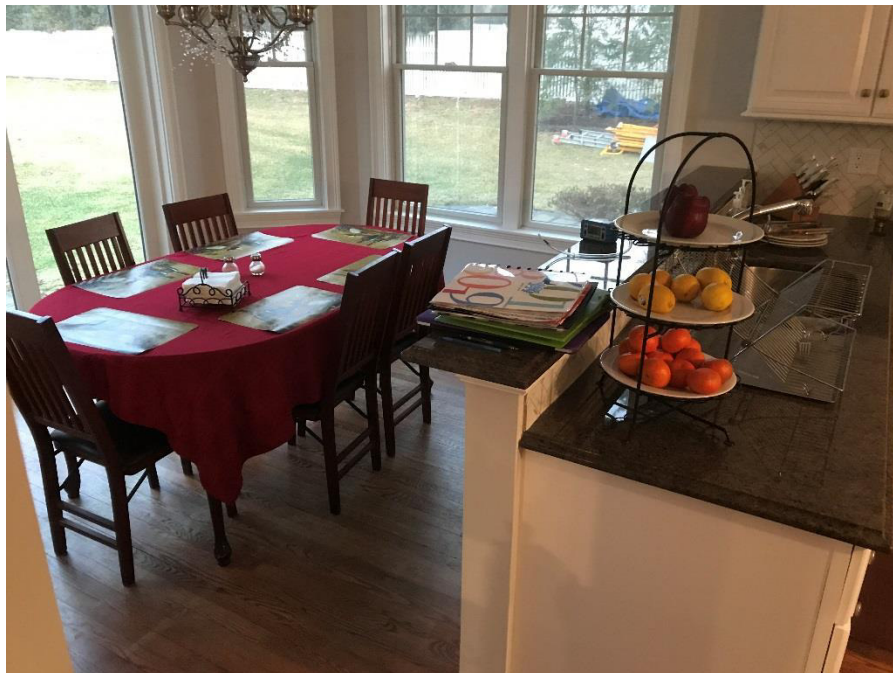
Photograph 5: View of ASL04 on a counter in the breakfast room on the first floor. 190205-ASL04-AS04-01 was collected at this location.

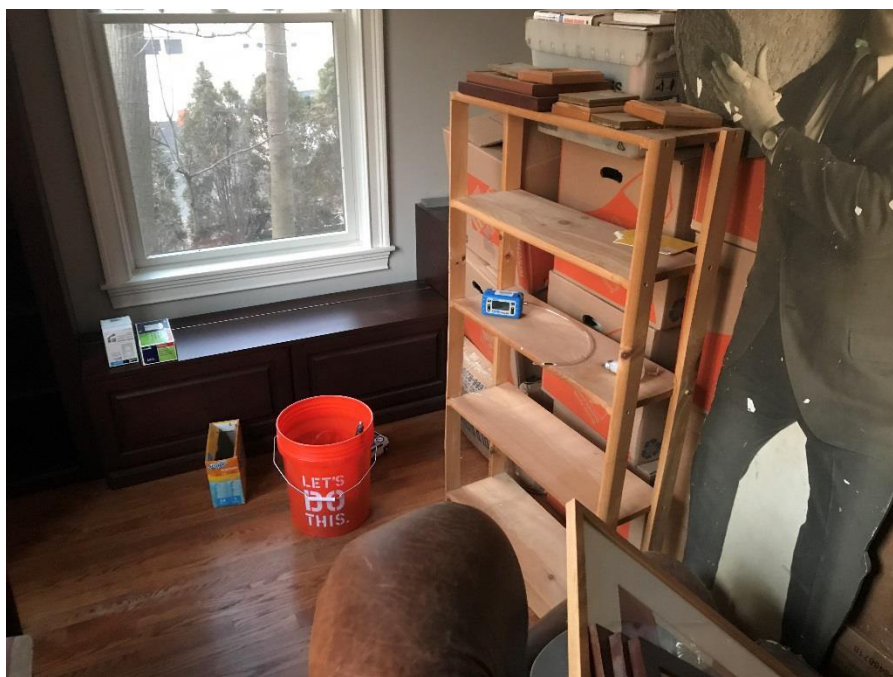
Photograph 6: View of ASL05 on a bookshelf in the den on the first floor. 190205-ASL05-AS05-01 was collected at this location.

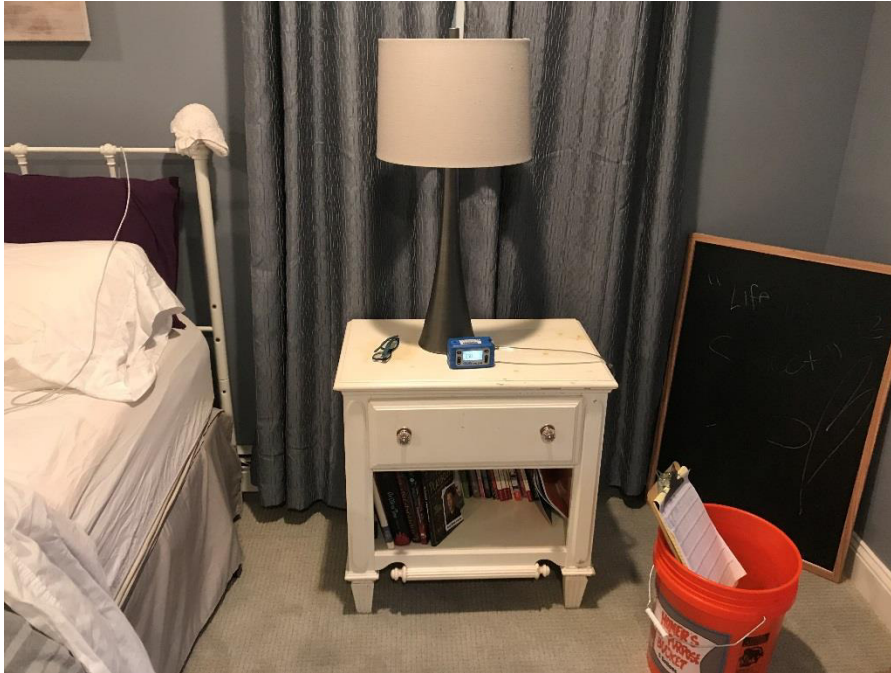
Photograph 7: View of ASL06 on a desk in a bedroom on the second floor. 190205-ASL06-AS09-01 was collected at this location. The GilAir pump initially deployed at this location failed shortly after starting sample collection earlier in the morning. Upon observing the failed pump later in the morning, RST 3 utilized a different GilAir pump and the flow rate was set at 0.40 L/min in order to achieve a suitable sample volume.

sampling pump deployed at ASL06 failed shortly after starting sample collection earlier in the morning. Upon observing the failed pump, a replacement pump was utilized to continue sample collection.

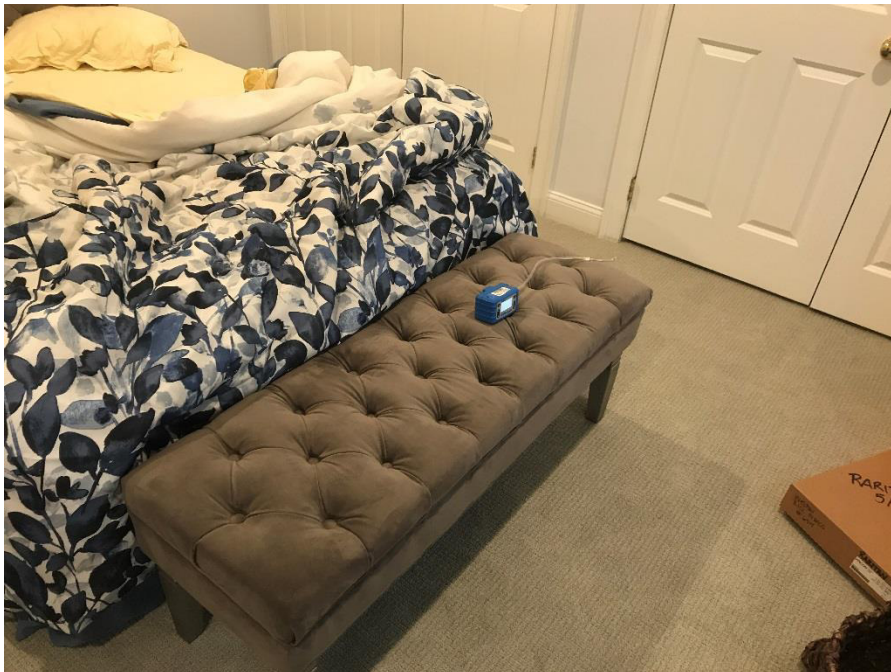
Photograph 8: View of ASL07 on a bench in a bedroom on the second floor. 190205-ASL07-AS07-01 was collected at this location.
